# **Component Procedures: Wiper Blade**

# Component Procedures: Wiper Blade

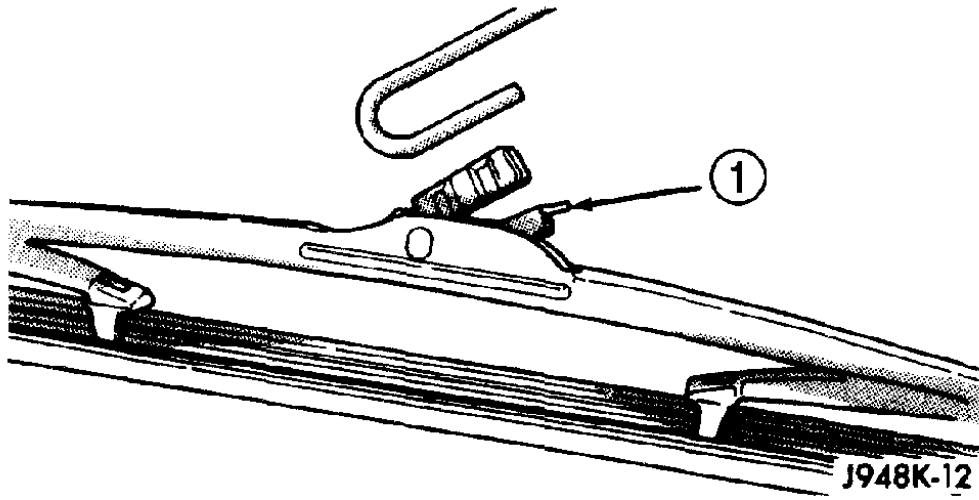
## Rear Wiper Blade (Article 2087432)

1 - RELEASE TAB

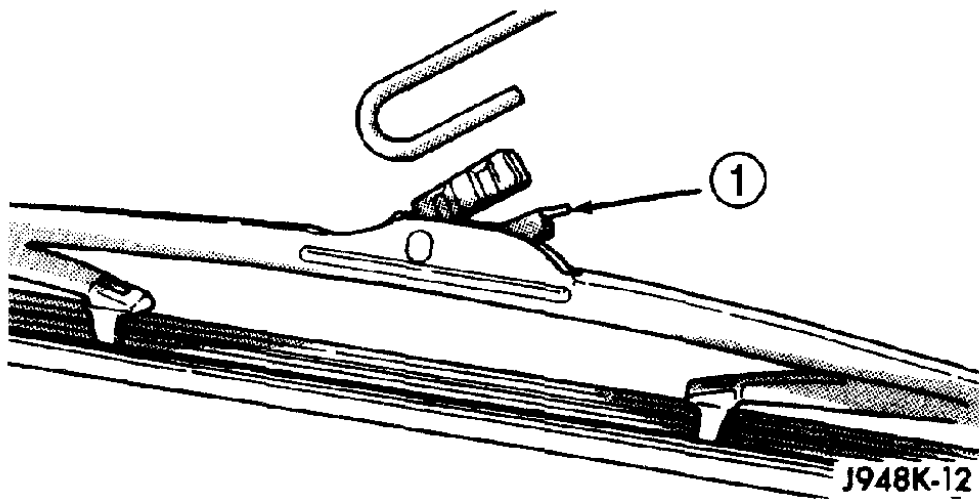
Wiper Blade (Article 2087429)

1 - RELEASE TAB
