# **Component Procedures: Shift Interlock**

## Selector Cable Adjustment (Article 1367663)

Automatic Transaxle Shift Mechanism Location Index (Article 1368504)

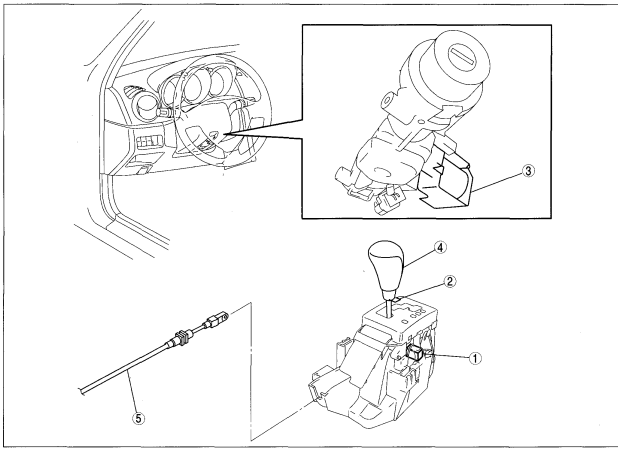
1	Shift-lock solenoid (See SHIFT-LOCK INSPECTION.) (See SHIFT-LOCK SOLENOID INSPECTION.)
2	Emergency override button (See EMERGENCY OVERRIDE BUTTON INSPECTION.)
3	Key interlock solenoid (See KEY INTERLOCK SOLENOID INSPECTION.)

4	Selector lever (See SELECTOR LEVER INSPECTION.) (See SELECTOR LEVER COMPONENT INSPECTION.) (See SELECTOR LEVER COMPONENT REMOVAL/INSTALLATION.) (See SELECTOR LEVER DISASSEMBLY/ASSEMBLY.)
5	Selector cable (See SELECTOR CABLE ADJUSTMENT.)

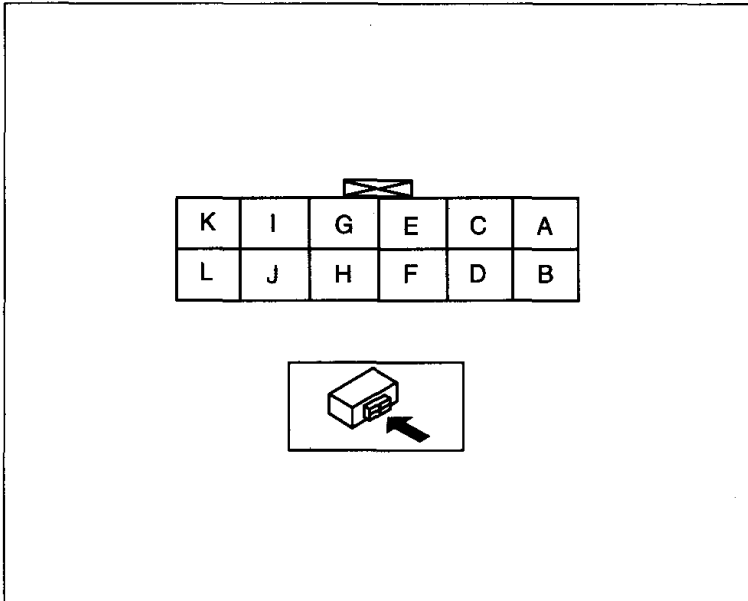
B3E0518W003

○—○ : Continuity

Selector lever position/range	Connector terminal												
	A	B	C	D	E	F	G	H	I	J	K	L	
M range - M			○									○	
M range Center M	○											○	
M range + M		○										○	
P position									○	○			
Except P position							○	○
